# Situation Photo Log

Tuesday, March 6, 2012

Kalamazoo River / Enbridge Spill

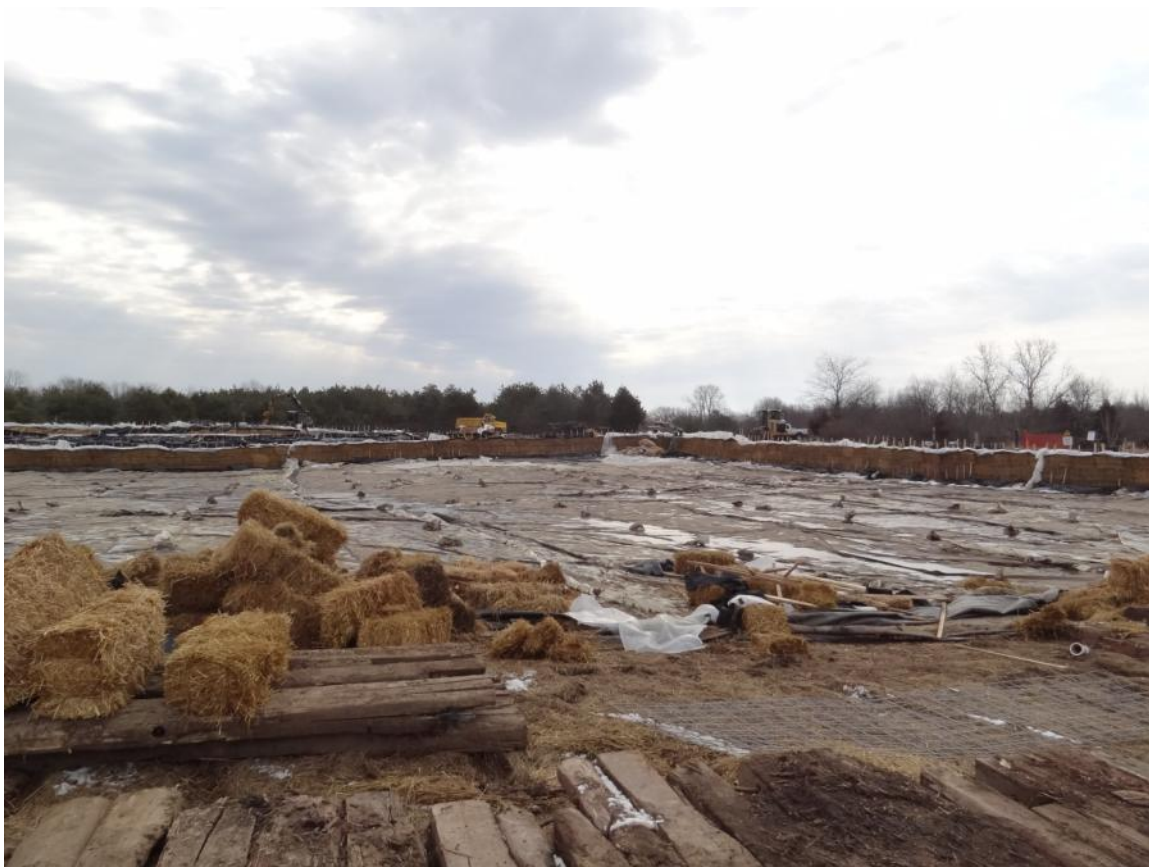
1. Turbidity Control Structure observed being demobilized.

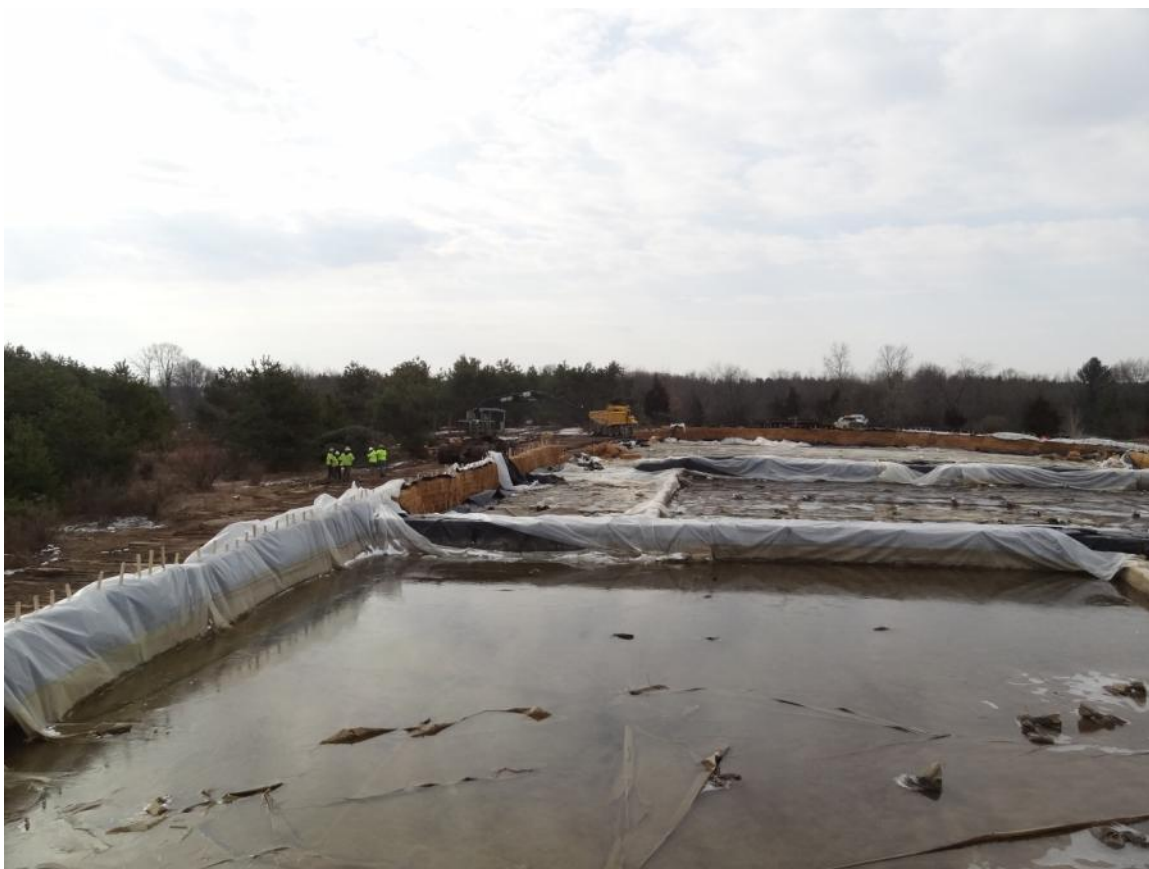
2. Turbidity Control Structure observed being demobilized.

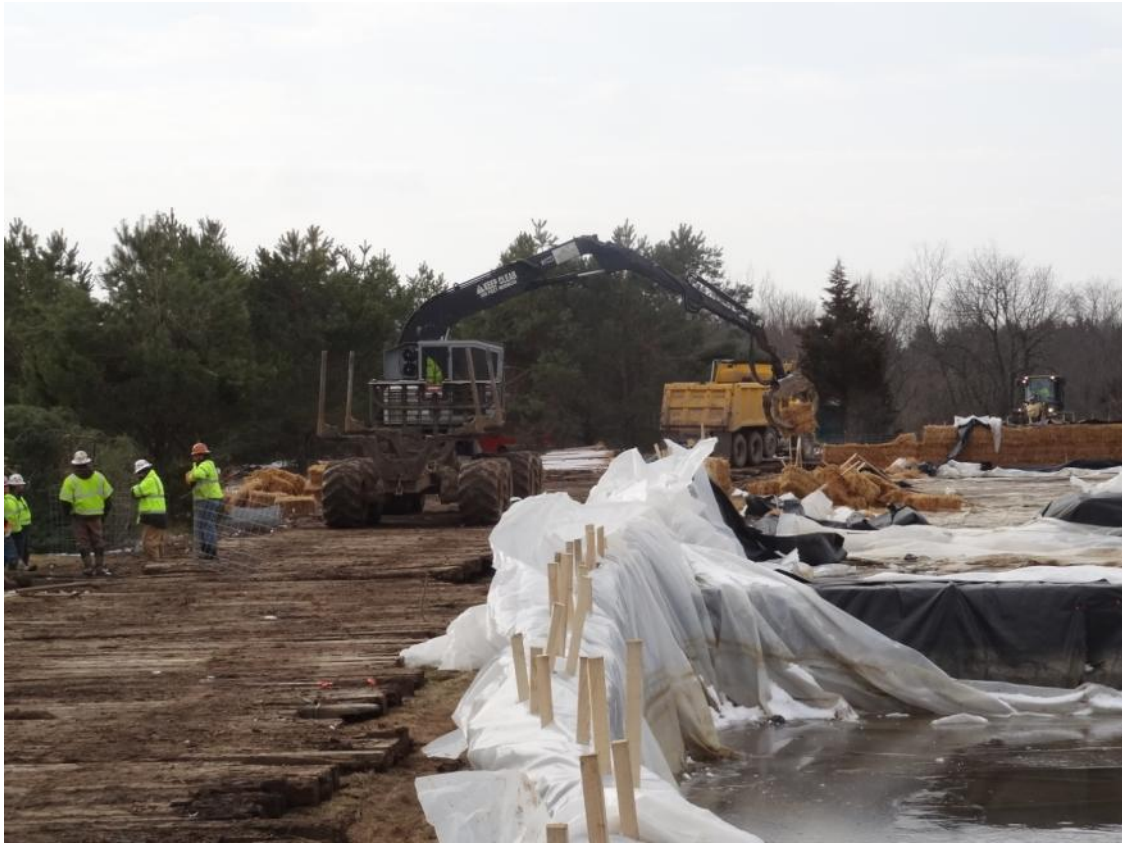
3. Turbidity Control Structure observed being demobilized.

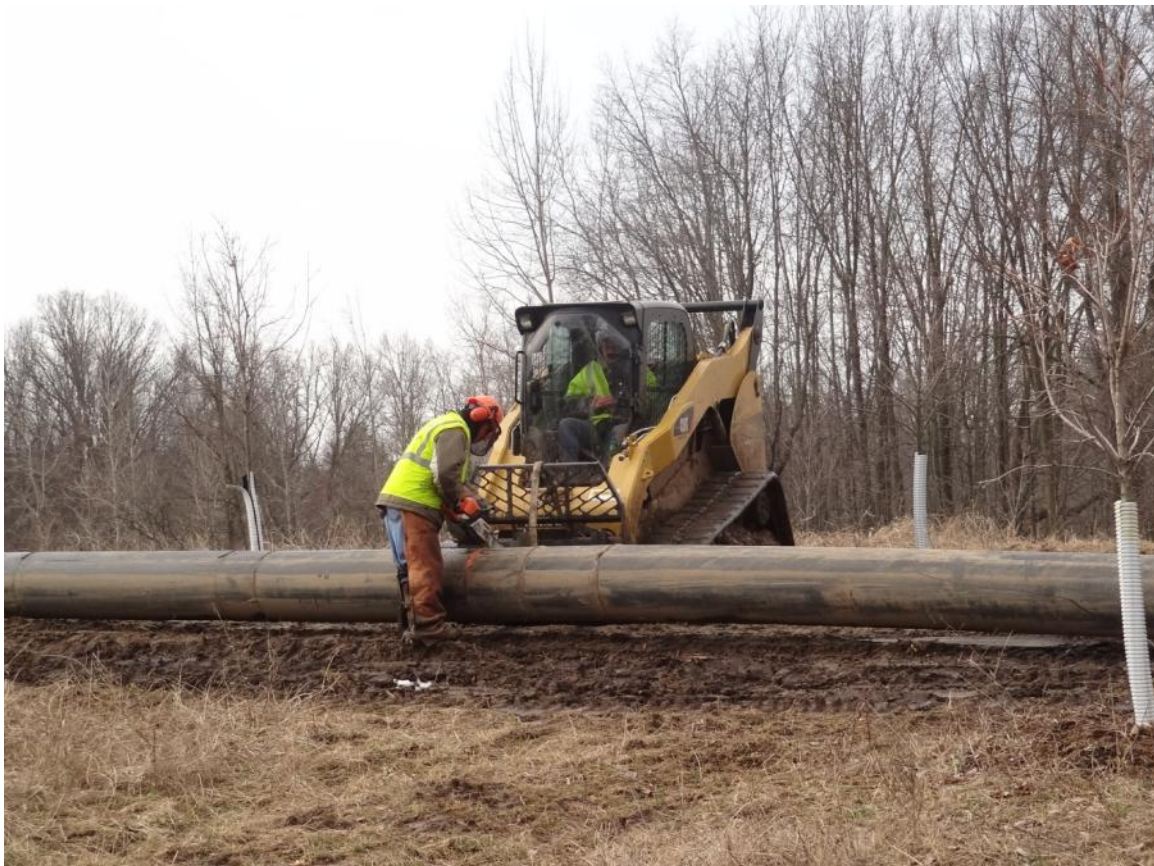
4. Turbidity Control Structure observed being demobilized.

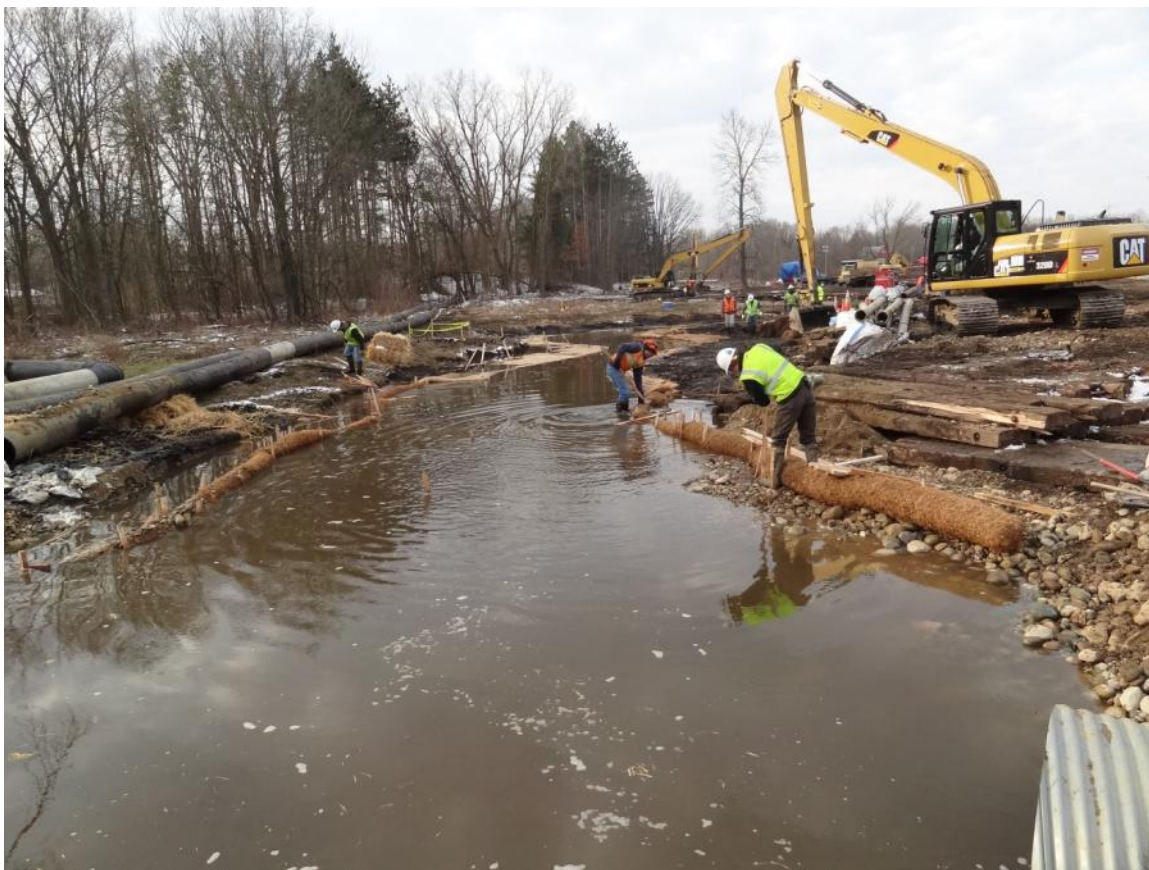
5. Talmadge Creek: restoration work south of A Drive.

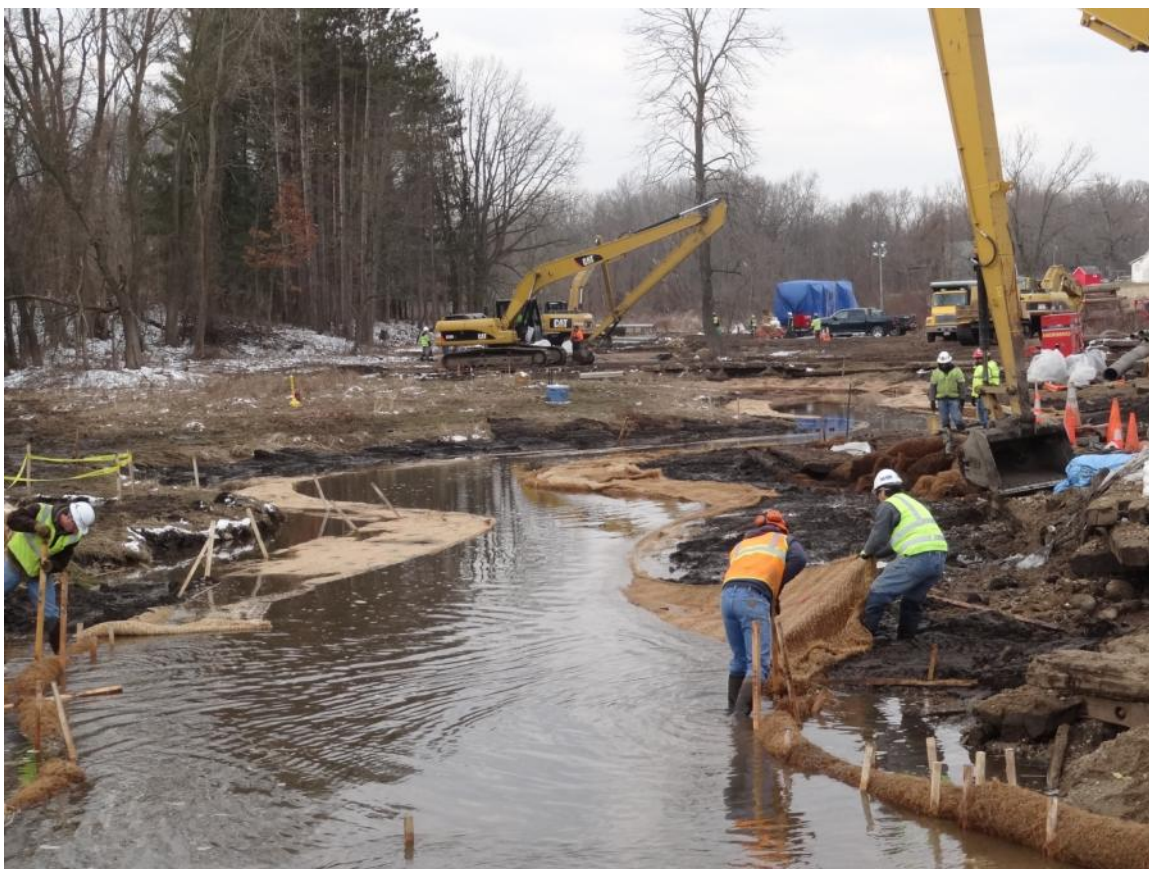
6. Talmadge Creek: restoration work south of A Drive.

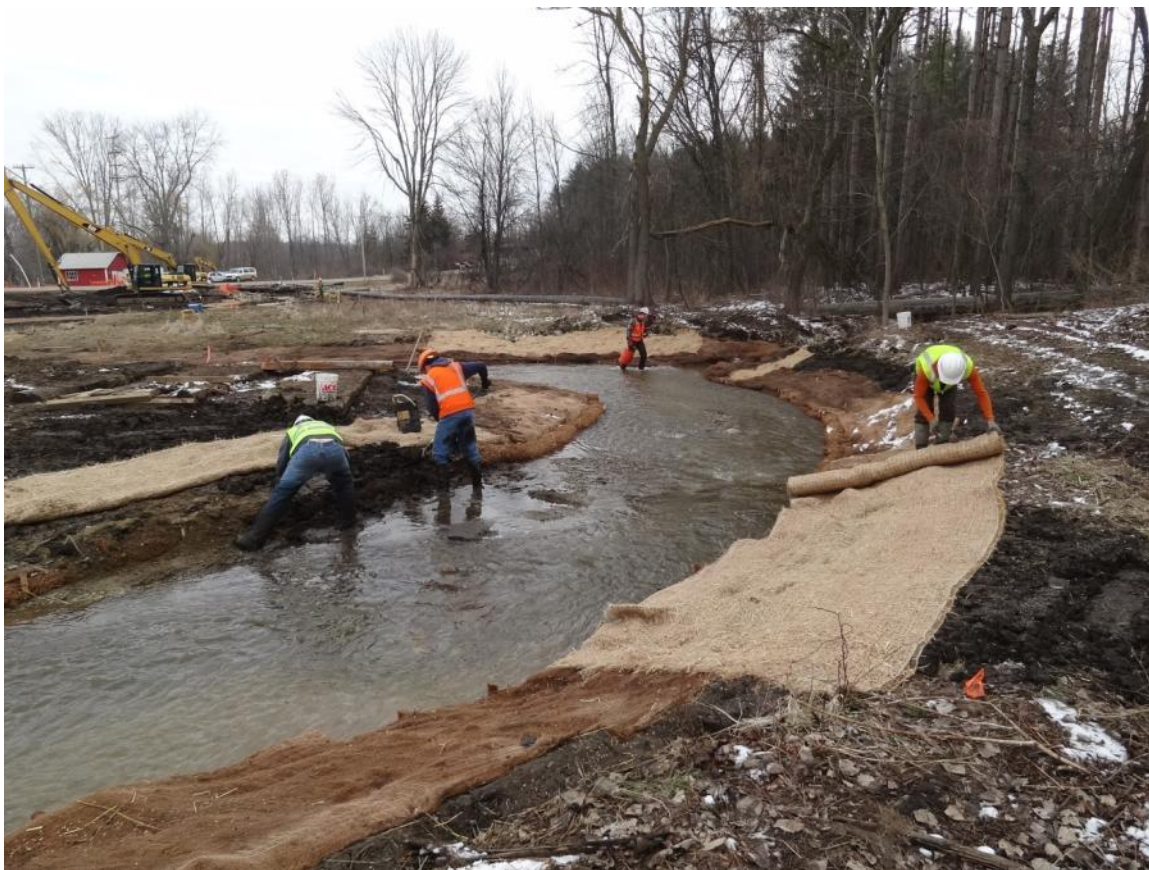
7. Talmadge Creek: restoration work near MP1.9.

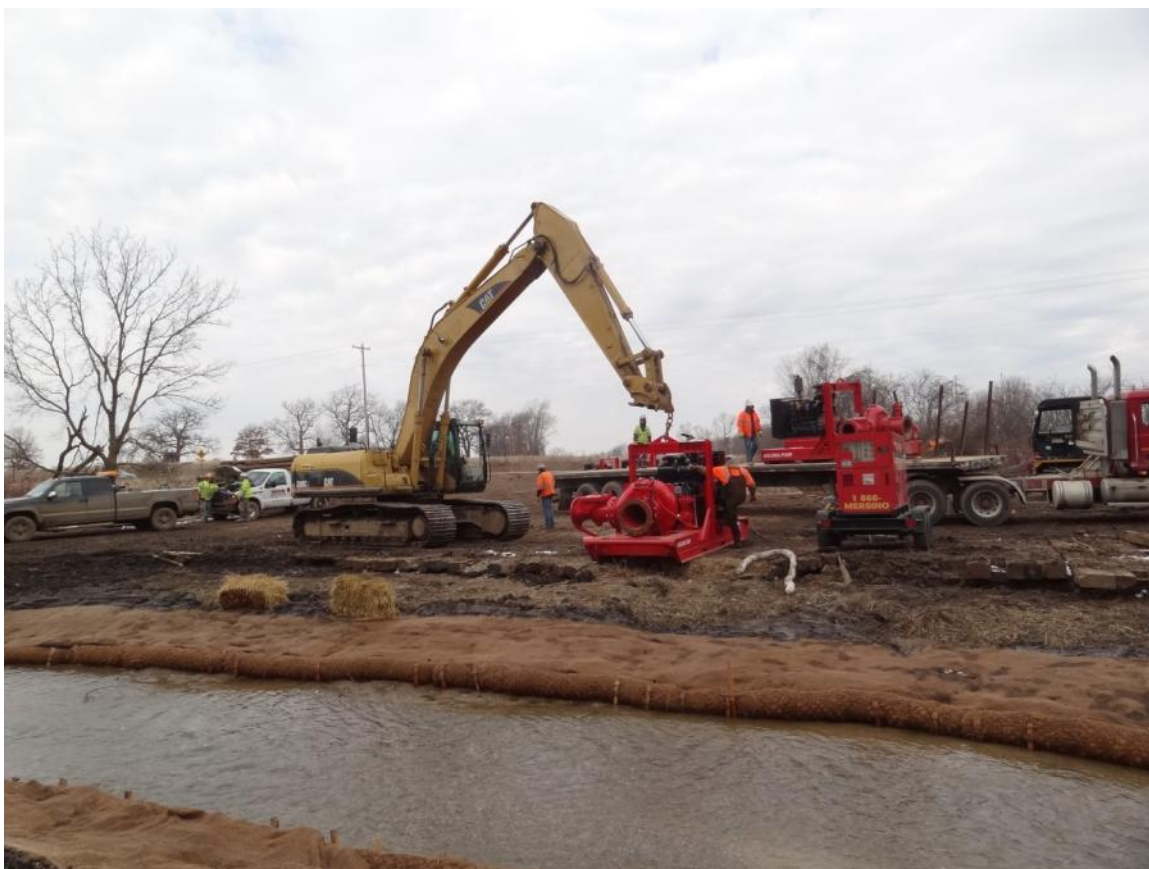
8. Talmadge Creek demobilizing of pumps near MP1.9.

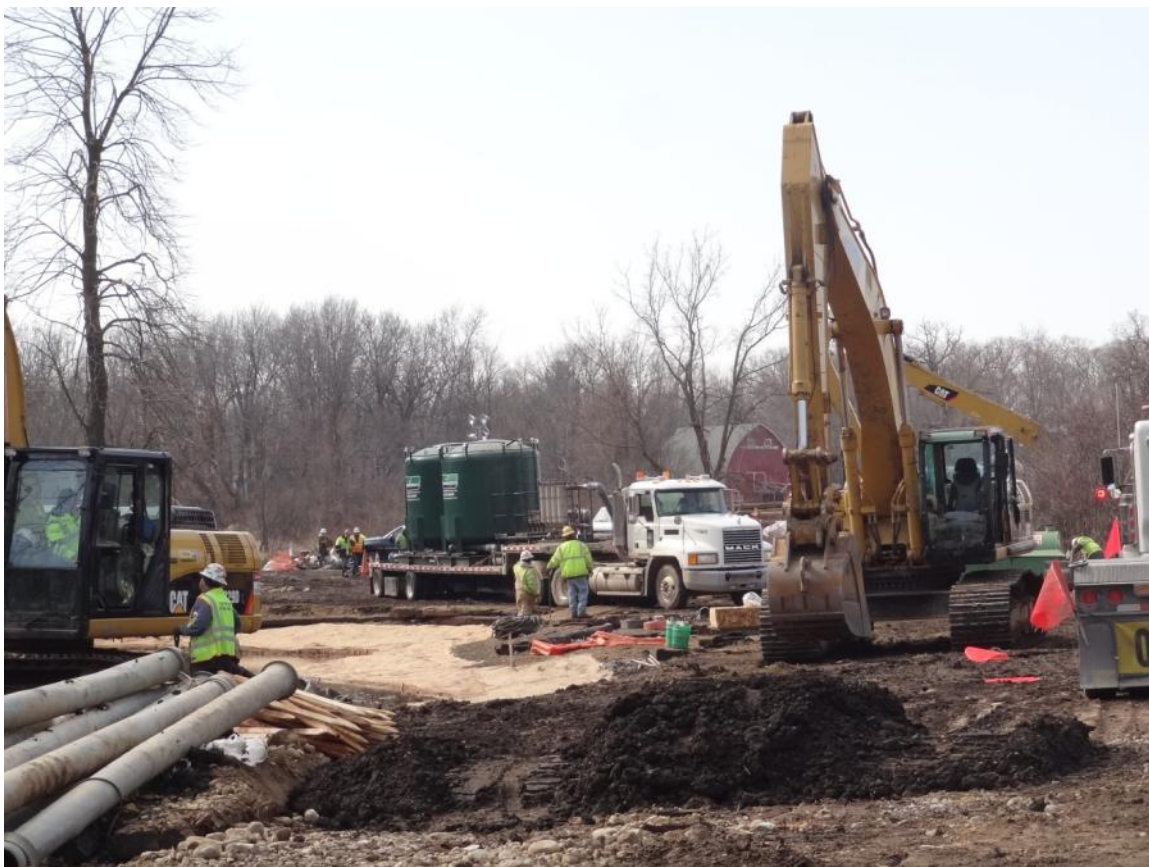
9. Talmadge Creek demobilizing of GAC system from near MP1.85.

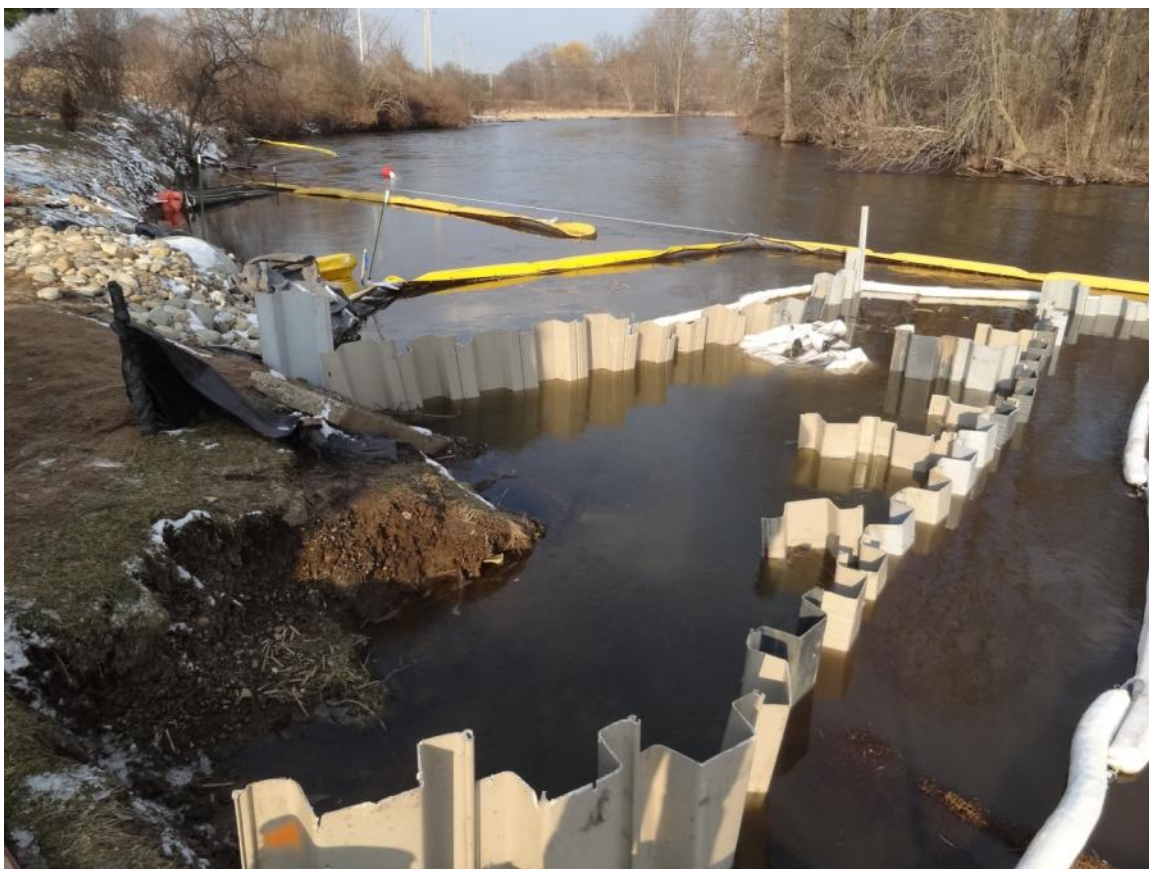
10. Confluence sheet piling removed from area prior to excavation.

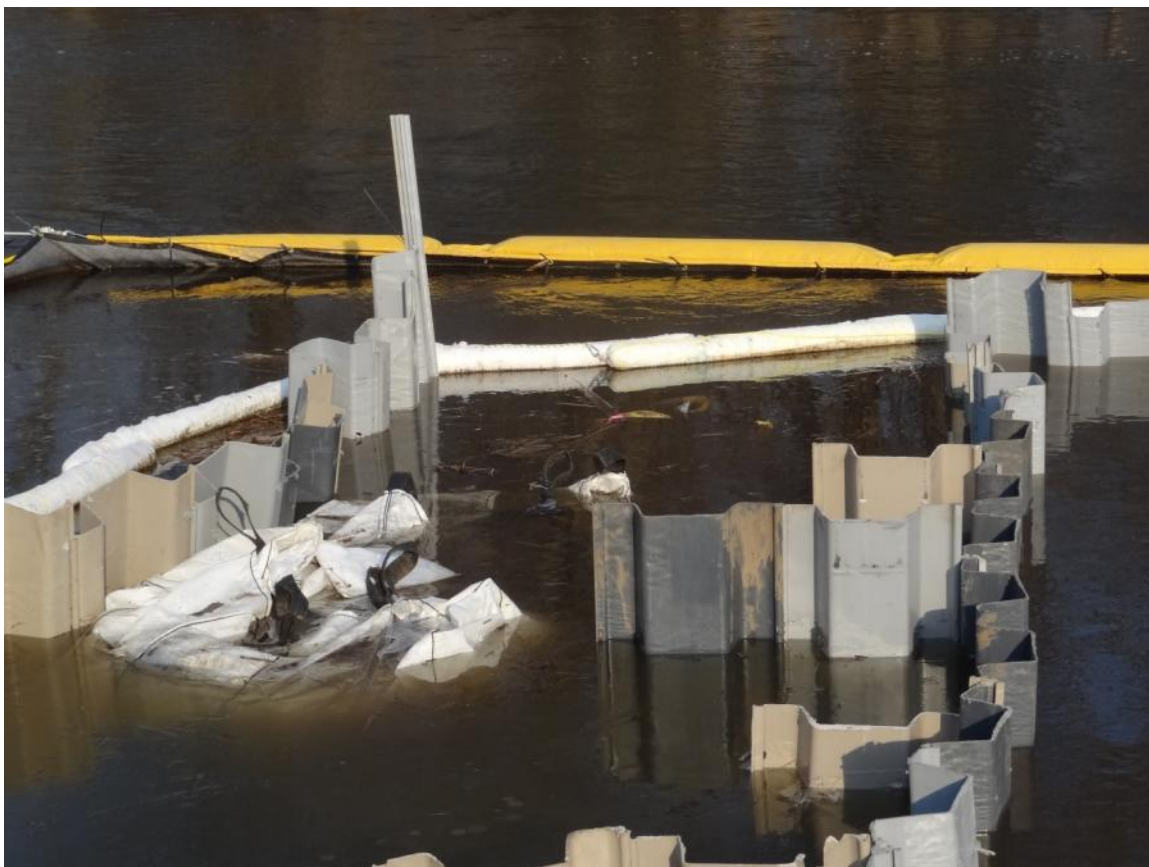
11. Confluence sheet piling removed from area prior to excavation.

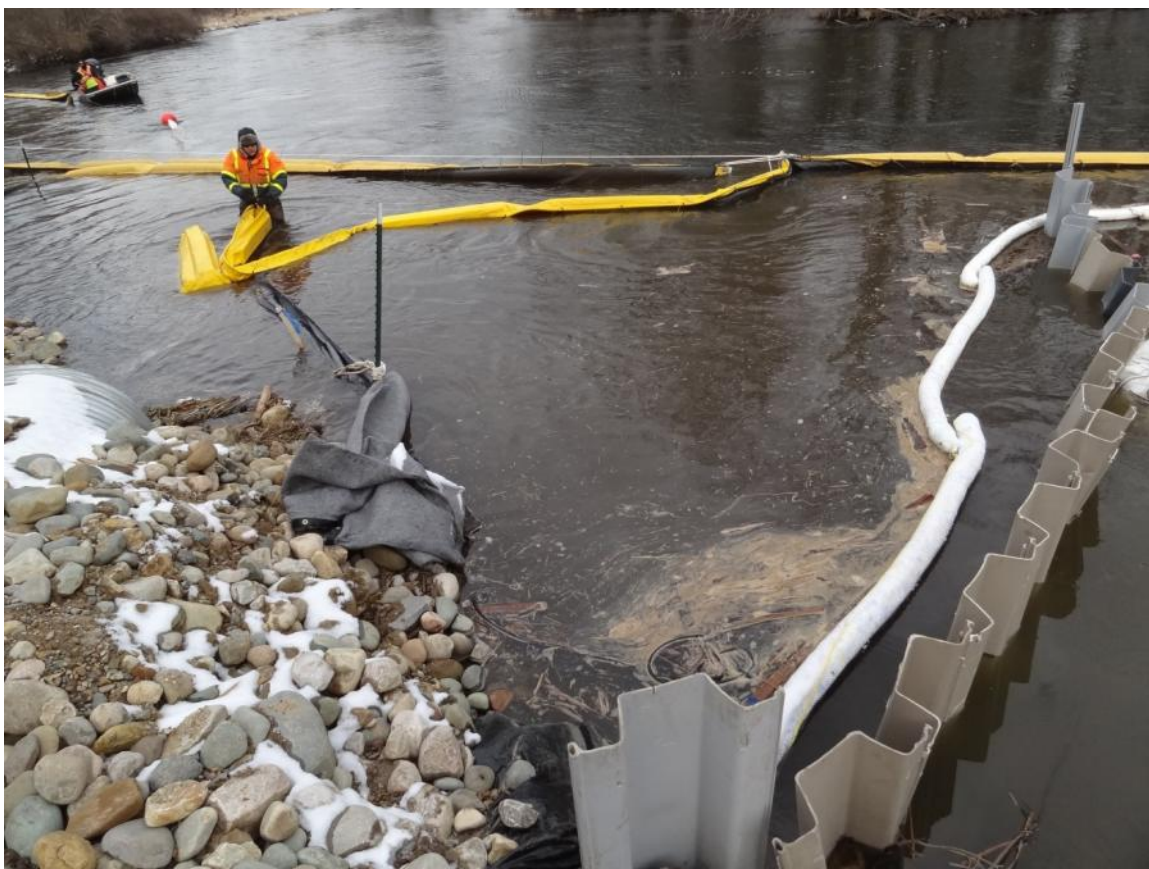
12. Confluence SWAT observed adjusting boom prior to sheet pile installation.

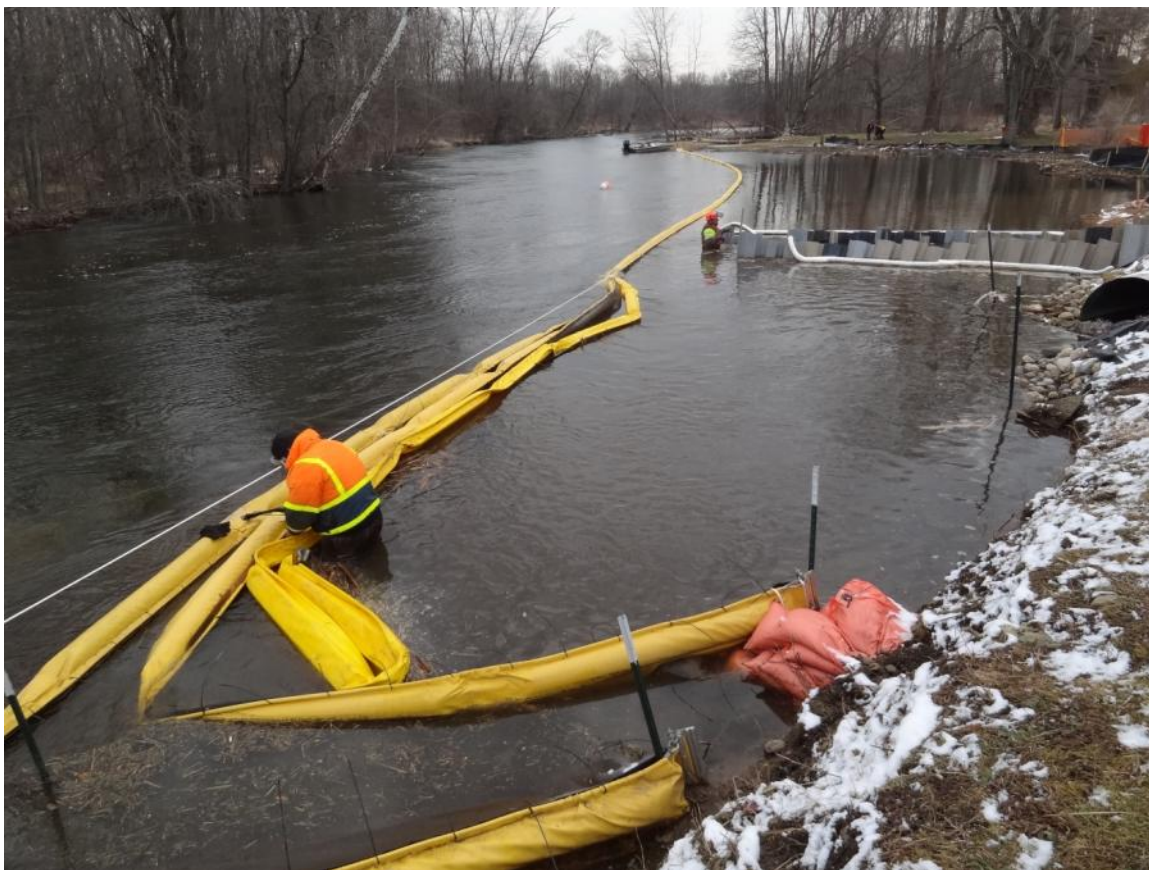
13. Confluence SWAT observed adjusting boom prior to sheet pile installation

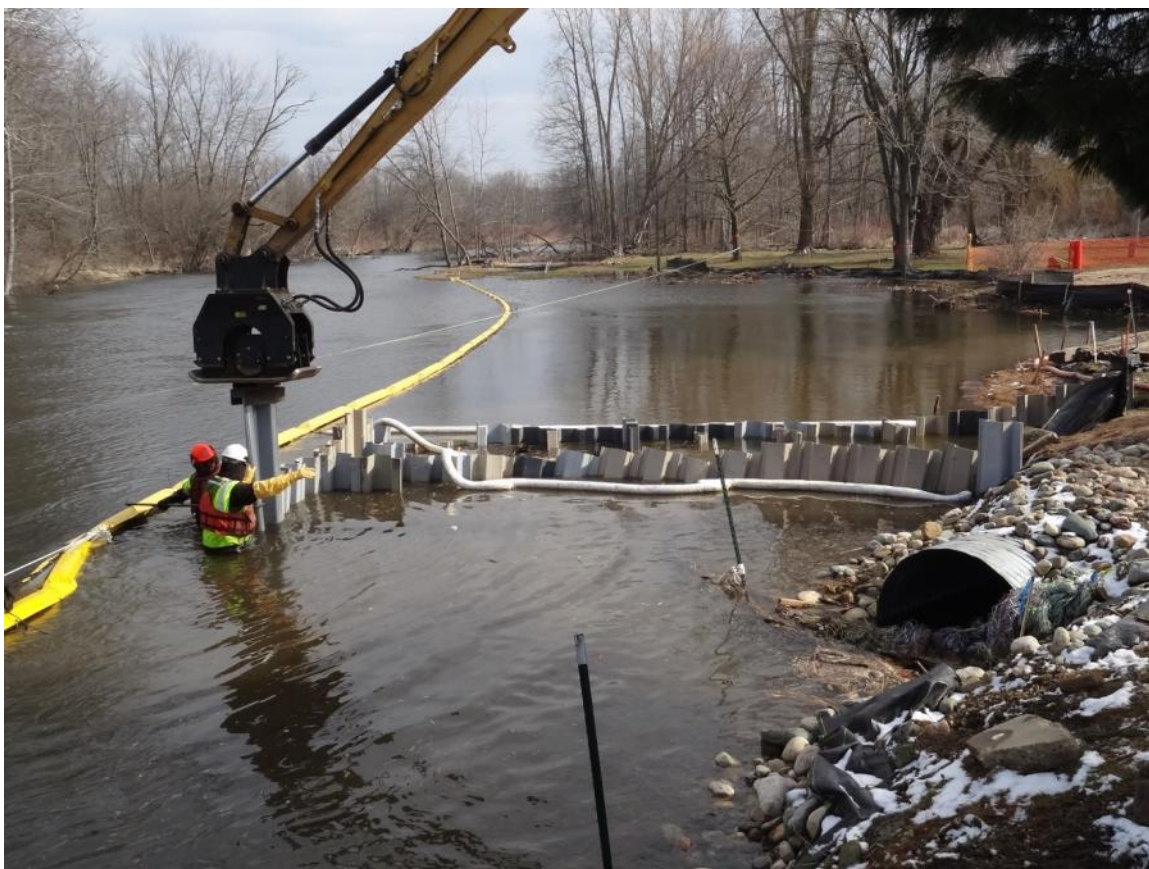
14. Confluence observed sheet piling installation at diversion structure discharge.

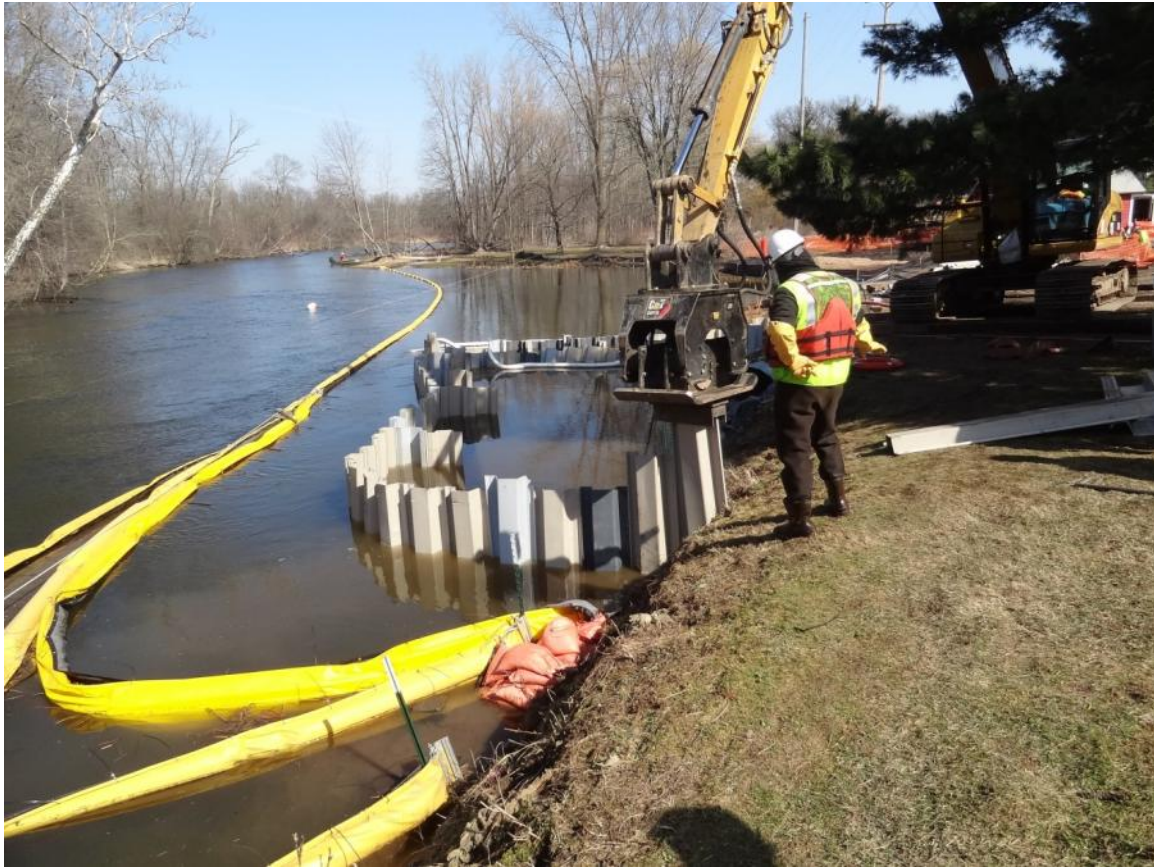
**15. Confluence observed sheet piling installation at diversion structure discharge.**

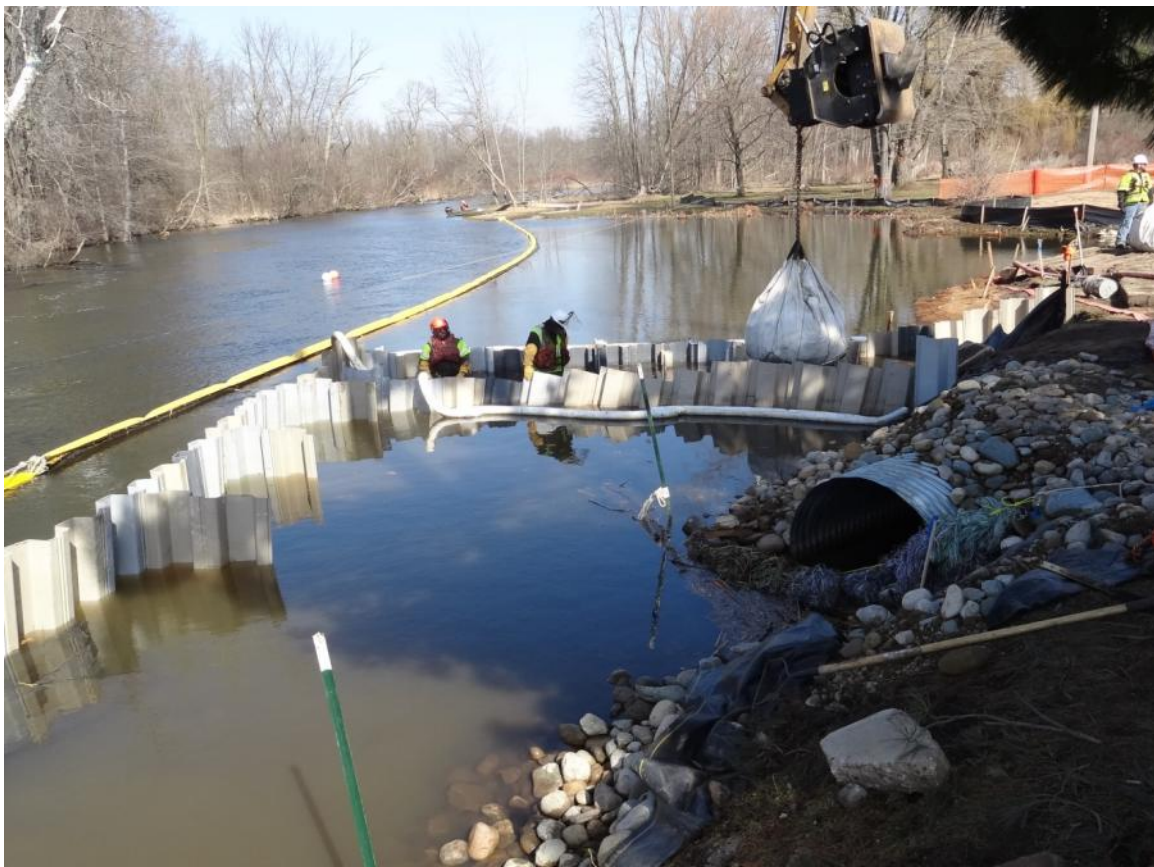
**16. Confluence observed crews removing super sacks from area to be excavated.**

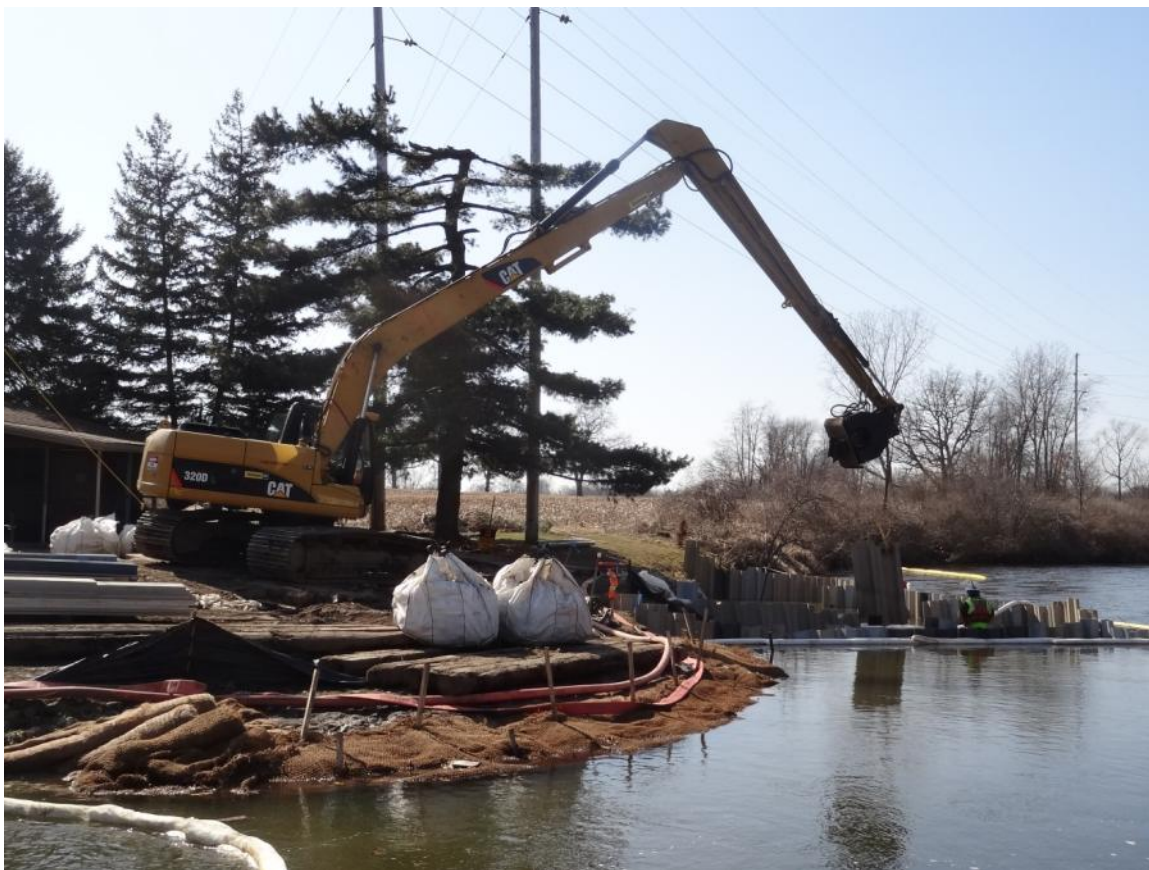
17. Confluence observed central sheet piling at diversion structure discharge.

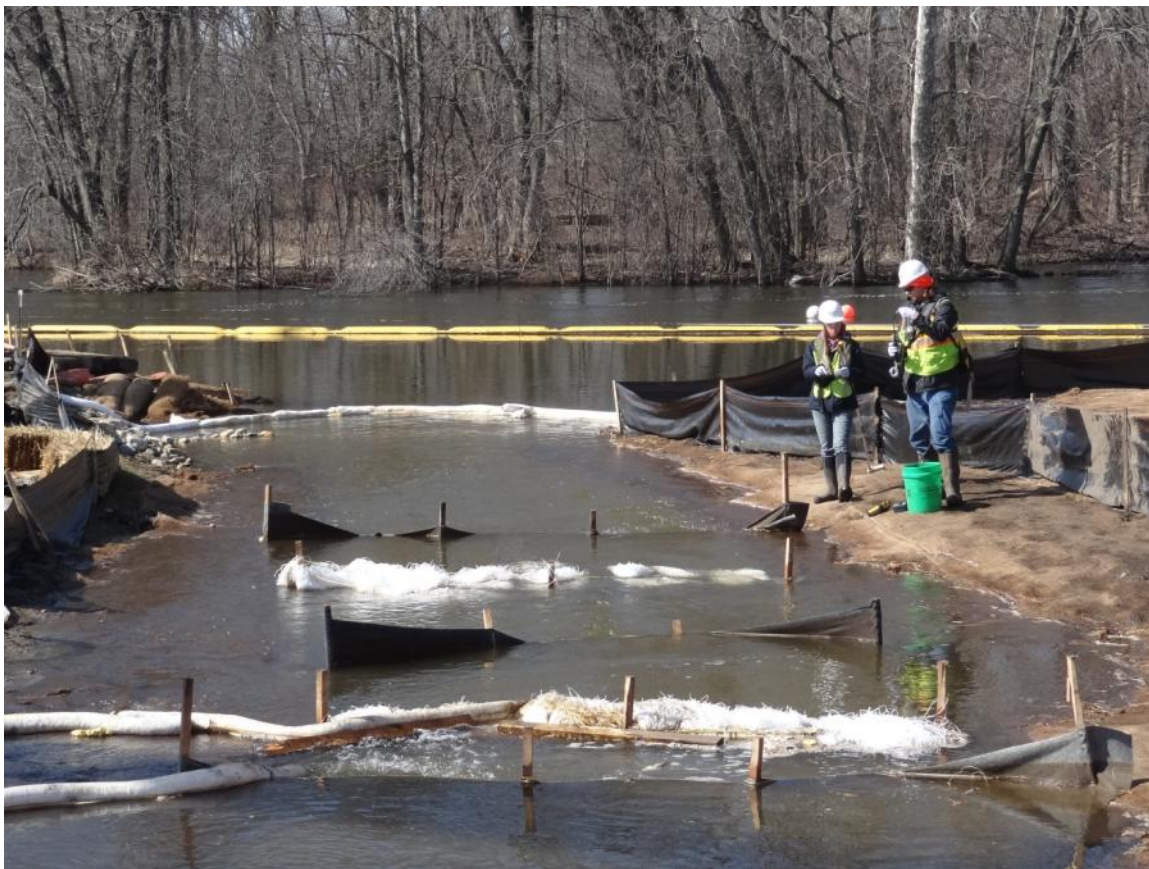
18. Talmadge Creek observed water quality monitoring.

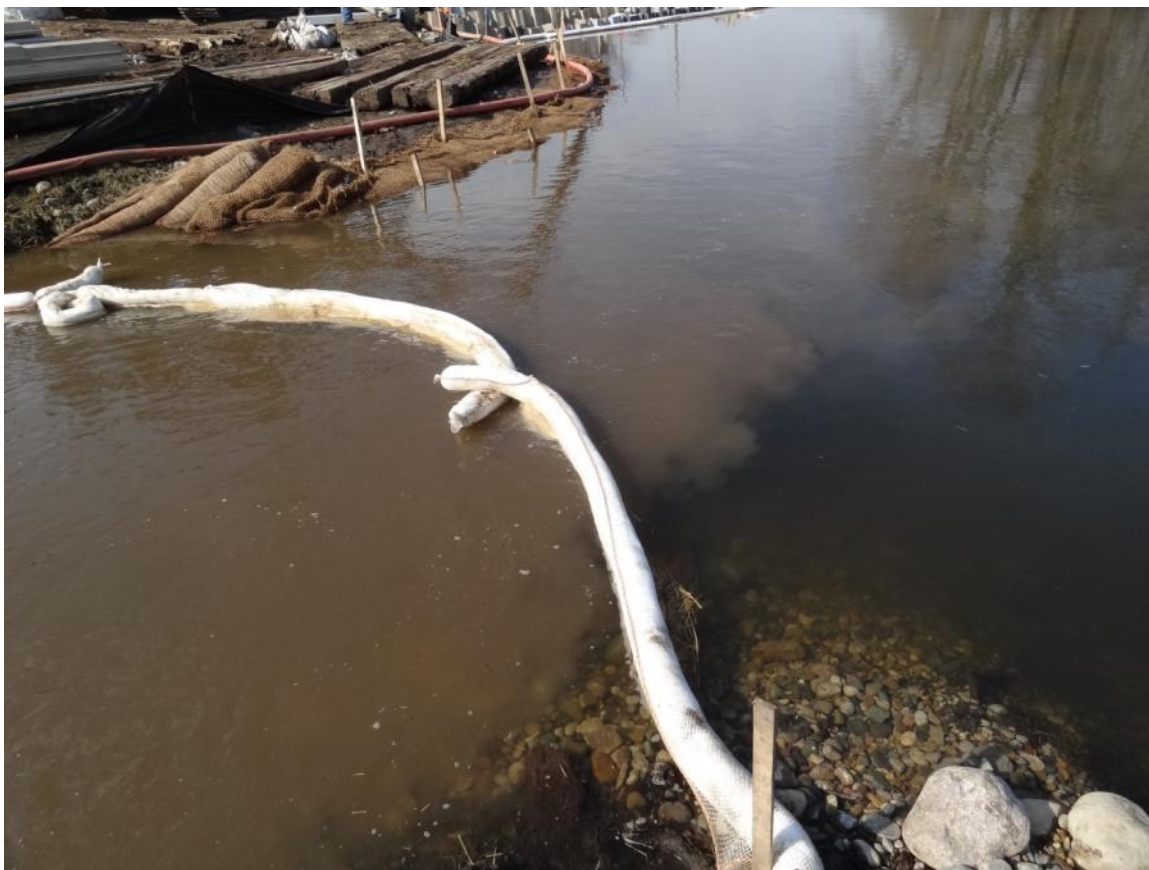
19. Confluence: turbidity observed.

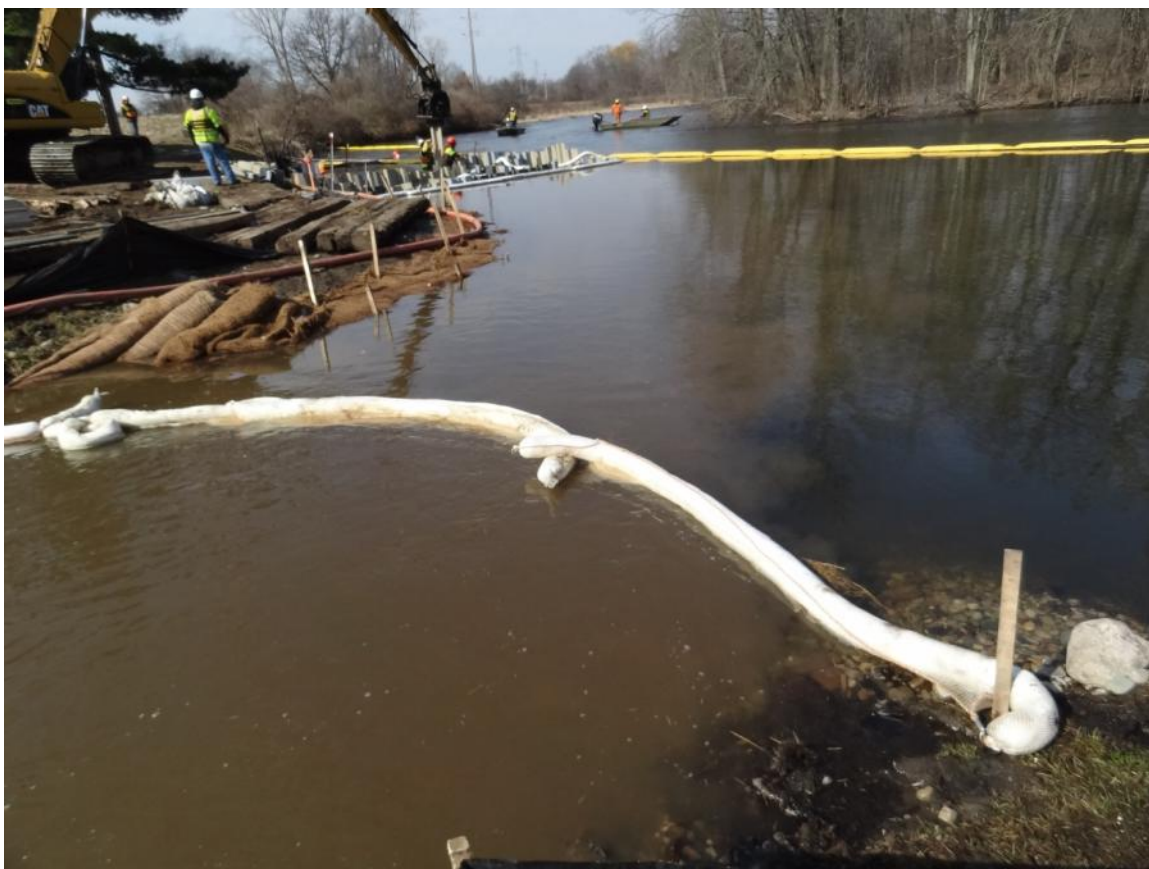
20. Confluence: turbidity observed.

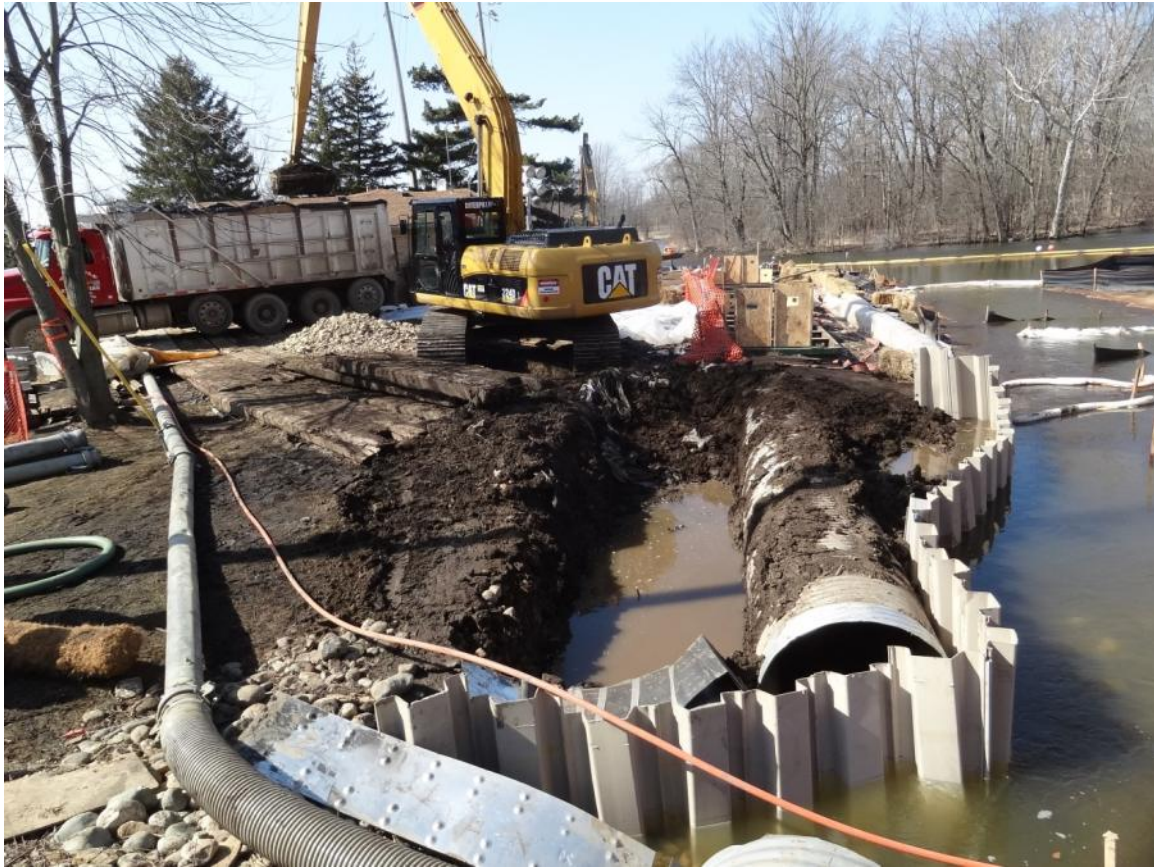
21. Confluence: observed removal of the diversion structure.

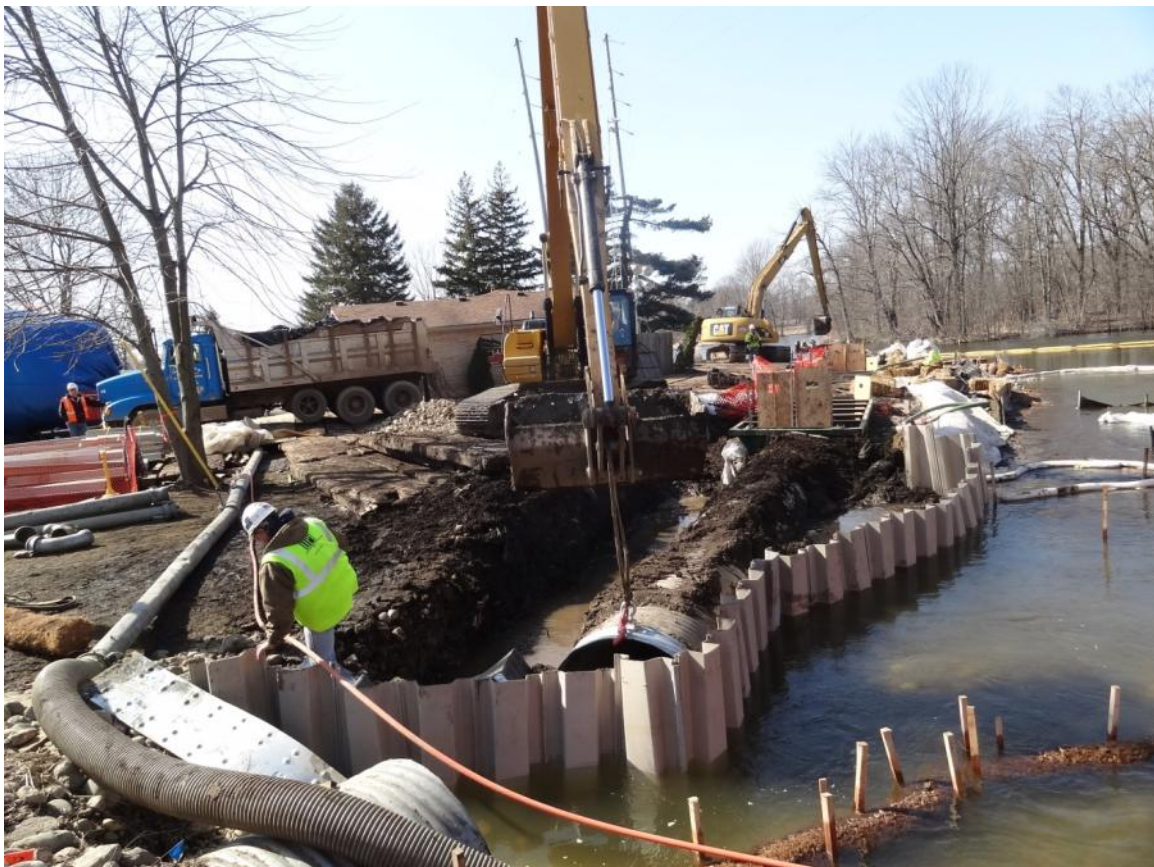
22. Confluence: observed removal of the diversion structure.

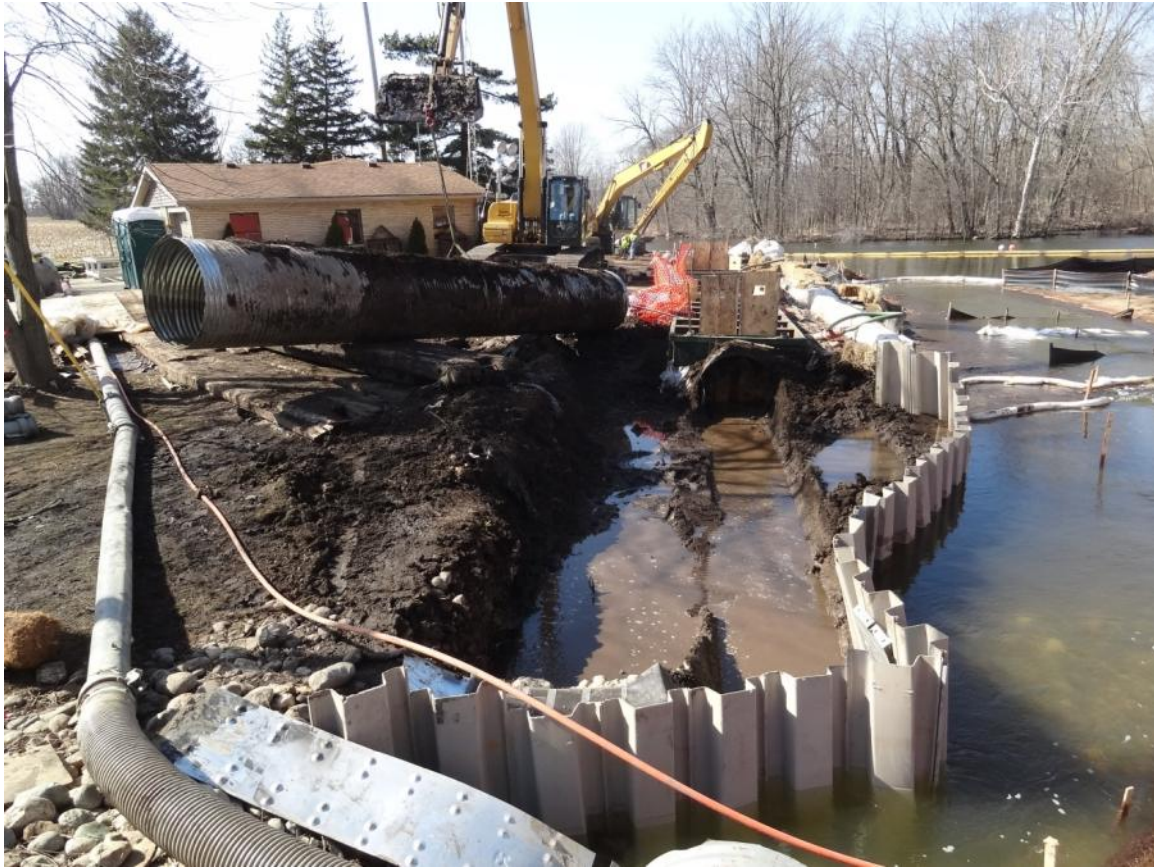
23. Confluence: observed removal of the diversion structure culvert.
